Leakage Current Waveforms and Arcing Characteristics of Epoxy Resin for Outdoor Insulators under Clean and Salt Fogs

Suwarno & S.K. Ardianto

School of Electrical Engineering and Informatics
Bandung Institute of Technology
Jl. Ganesha 10 Bandung 40132, INDONESIA
Email: suwarno@ieee.org

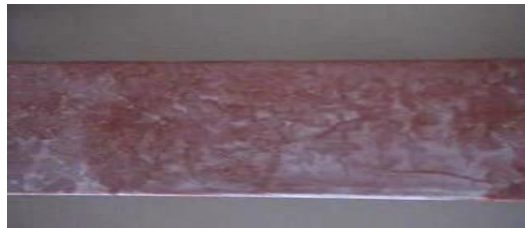
Figure 1 Epoxy resin samples used in experiment (a) clean (b) kalin-salt polluted.

and 1 atm. The samples were prepared in the form of blocks with dimension of $250 \times 50 \times 20 \text{ mm}^3$ as shown in Figure 1(a) clean and 1(b) kaolin-salt polluted. For obtaining good contact with electrode, the two ends of the samples were coated with conductive silver paint. The samples was subjected to various test conditions such as clean fog and salt fog, kaolin pollution and kaolin-salt pollution under clean or salt fog. Kaolin-salt pollution was obtained by adding 40 g kaolin into 1 liter water. Salt was added into the solution for obtaining the desired conductivity. The conductivity was varied from 0.6 mS/cm – 4.0 mS/cm which represented the degree of pollution from light to heavy derived from Equivalent Salt Deposit Density (ESDD) according to IEC 507[20].

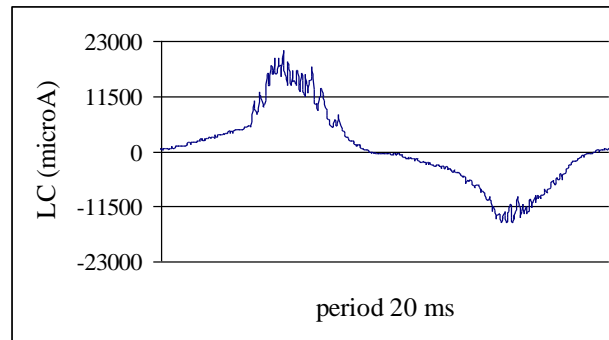
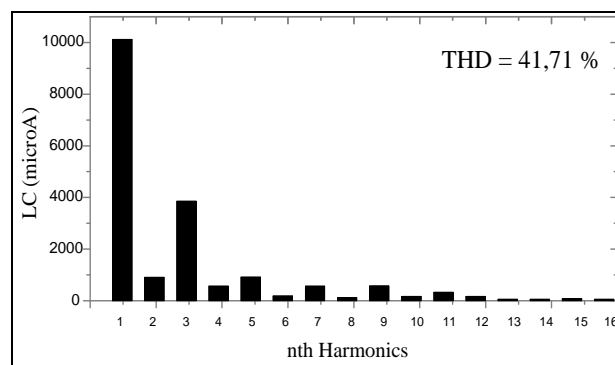
Figure 3 Typical leakage current on insulator surface (a) and harmonic components (b).

The leakage current flowed on the insulator surface was measured by measuring the voltage across a series resistance of 10 k Ω using a Digital Oscilloscope with bandwidth of 100 MHz, and the maximum sampling rate of 1 GS/s. LC waveforms were digitized and the digital data was transferred to a personal computer through a GPIB for further analysis. The measurement system is shown in Figure 3. Harmonic content of LC was analyzed using FFT (Fast Fourier Transform). Under polluted conditions, leakage current on the outdoor insulators usually distorted from its sinusoidal form as shown in Figure 3. The degree of distortion is expressed as Total Harmonic Distortion (THD) which is defined as

$$\text{THD} = \frac{\sqrt{\sum_{n=2}^{\infty} I_n^2}}{I_1} \quad (1)$$

where I_1 is fundamental component of LC (1st harmonic) and I_n is n th harmonic component of LC.

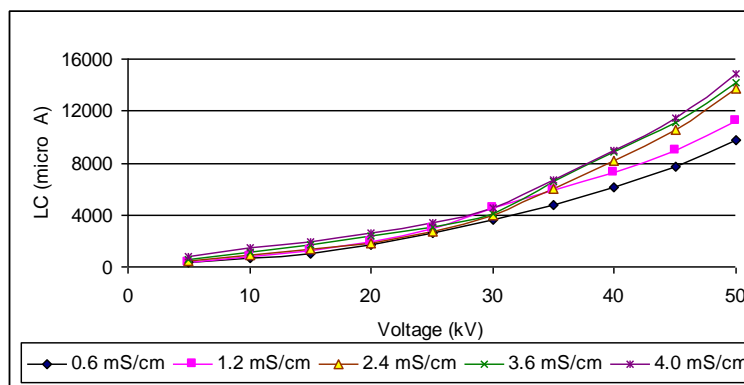
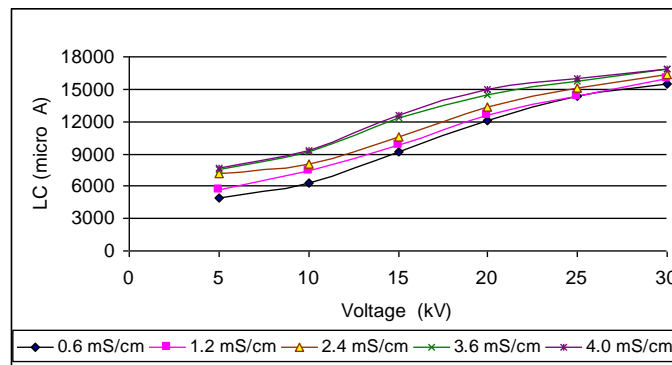
Figure 7 Dependence of LC magnitude on applied voltage for kaolin-salt polluted samples under clean fog at (a) low RH and (b) high RH.

Figure 7 shows typical leakage current magnitude of kaolin-salt polluted insulators as a function of applied voltage under clean fog at (a) low RH and (b) high RH. Figure 7(a) shows that the discrepancies of LC magnitudes of different pollution levels at low RH is larger at higher applied voltage. This indicates that the effect of kaolin-salt pollution becomes stronger at higher voltage. Similar pattern was reported for glass insulator [23]. Figure 7(b) shows that at high RH the LC magnitude was higher. Under high humidity, the water molecules were absorbed by pollutant leading to the increase of surface conductivity and LC magnitude [24,25]. However, at high RH large discrepancy of LC magnitude was not observed at high applied voltage. This was caused by the fact that at high LC magnitude the drying effect took place and the effect of high RH reduced leading to the reduction of LC magnitude.

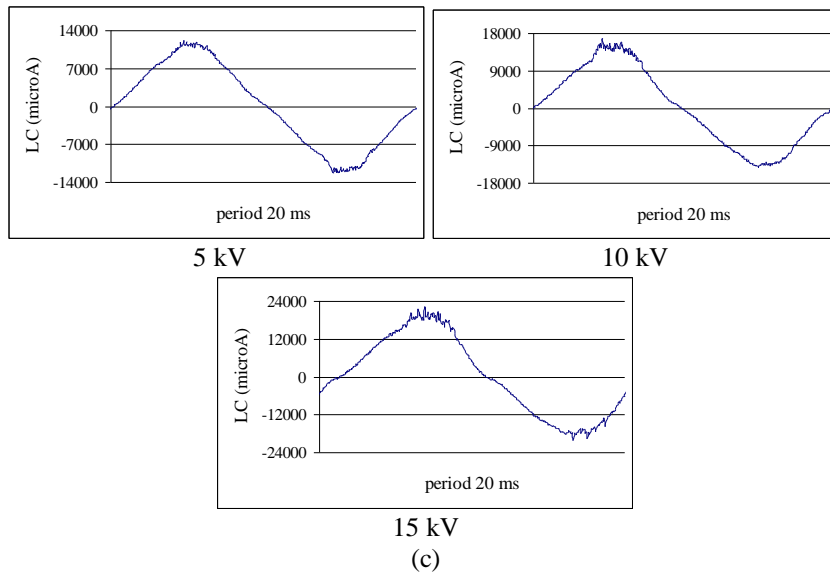
Figure 12 Typical LC waveforms for kaolin-salt polluted at 3.6 mS/cm under clean fog and applied voltage of 5, 10 and 15 kV at (a) low RH (b) medium RH and (c) high RH

Figure 12 shows typical LC waveforms for kaolin-salt polluted at 3.6 mS/cm under clean fog and applied voltage of 5, 10 and 15 kV at (a) low RH (b) medium RH and (c) high RH. The figure clearly indicates that LC magnitude of kaolin-salt polluted samples greatly affected by both applied voltage and humidity. In general the LC magnitude significantly larger than those from kaolin-polluted samples under salt fog condition at same conductivity but the distortion of the LC waveforms from its sinusoidal was smaller as indicated by THD. THD was slightly increased with applied voltage and strongly affected by humidity. At high RH the LC amplitude was large and the waveform distortion was also high especially at the peak of the LC waveforms. This correlated with local arc due to corona since corona usually occurs at the highest part/peak of the applied voltage [26]. Harmonic analysis indicated that odd harmonic components especially 3rd, 5th and 7th appeared with relatively high magnitude. Similar behavior was reported for suspension insulators [27] and post pin EPDM insulator [28]. This symmetrical LC waveform with dominant odd harmonic components was correlated with the appearance of spark on the sample surface at high RH which enhanced the distortion of LC waveforms leading to the increase of THD. The values of THD as function of voltage and RH is shown in Figure 13.
